A Review of Little Hunting Creek Watershed, Paul Spring Segments 1 & 2 (Brickelmaier Park and Goodman Park), Hollin Hills Stream Restoration 100% Plans

By R.H. Simmons, March 2020

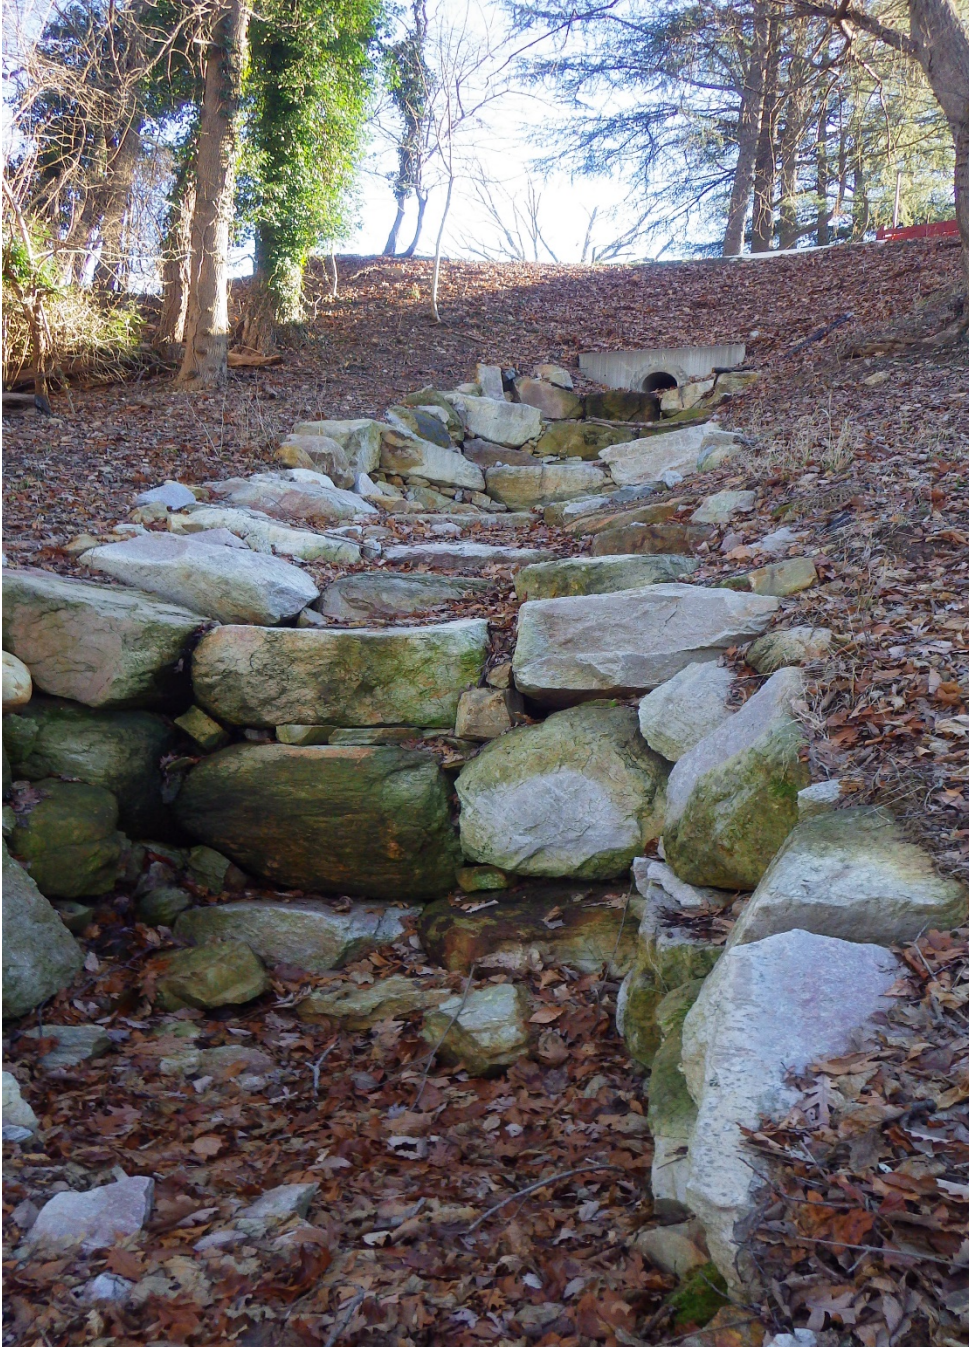
Fig. 1. A high-quality, joint National Park Service-Department of Defense project to restore a stormwater blowout on a steep slope in old-growth Mesic Mixed Hardwood Forest at Arlington Woods bordering Arlington National Cemetery and Arlington House in Arlington County, Virginia. Natural-to-the-site quartzite sandstone boulders were carefully installed along the blowout, forming a series of plunge steps, and no trees were harmed or removed for the project. Infestations of English Ivy and other non-native invasive plants cover much of the forest, as they do at the Hollin Hills sites, though are slowly being removed here. The effects of sheetflow runoff from impervious surface into the site are also much the same as observed at Goodman Park. Also notice that because the forest community was retained, the site is not planted with a myriad of inappropriate species. Photo by R.H. Simmons.

adding large quartzite sandstone boulders or cobbles to the plunge pool drop-off at the outflow of the culvert (Fig. 1).

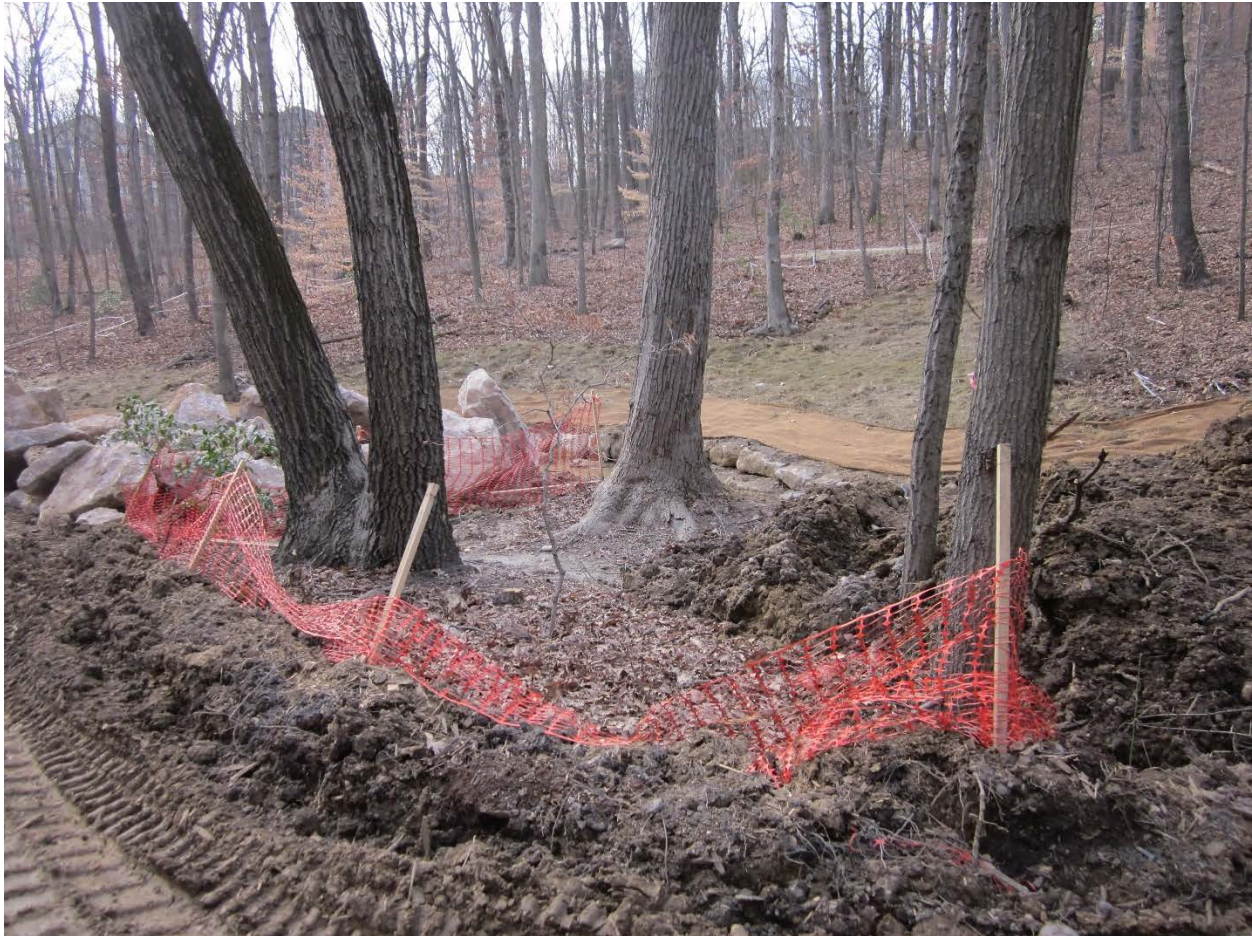
Fig. 3. A “tree save area” within the stream construction project along the upper headwaters of Winkler Run in the City of Alexandria, Virginia. All trees in the save area soon died following construction of the new stream channel as a result of root damage and destruction of the soil microorganisms necessary in sustaining a healthy forest community. This natural channel design project would be considered high-end by many of today’s standards. Photo by R.H. Simmons.

Many more canopy trees than the above, however, will undoubtedly be lost in constructing these projects. Even though sections of trees are designated for protection, there is no effective way to access either site with heavy construction equipment to perform the extent of digging, hauling, recontouring, and reconstructing of stream channels that is proposed without critically damaging the trunks, roots, soil structure, and soil microorganisms of the trees to be saved (Fig. 3).

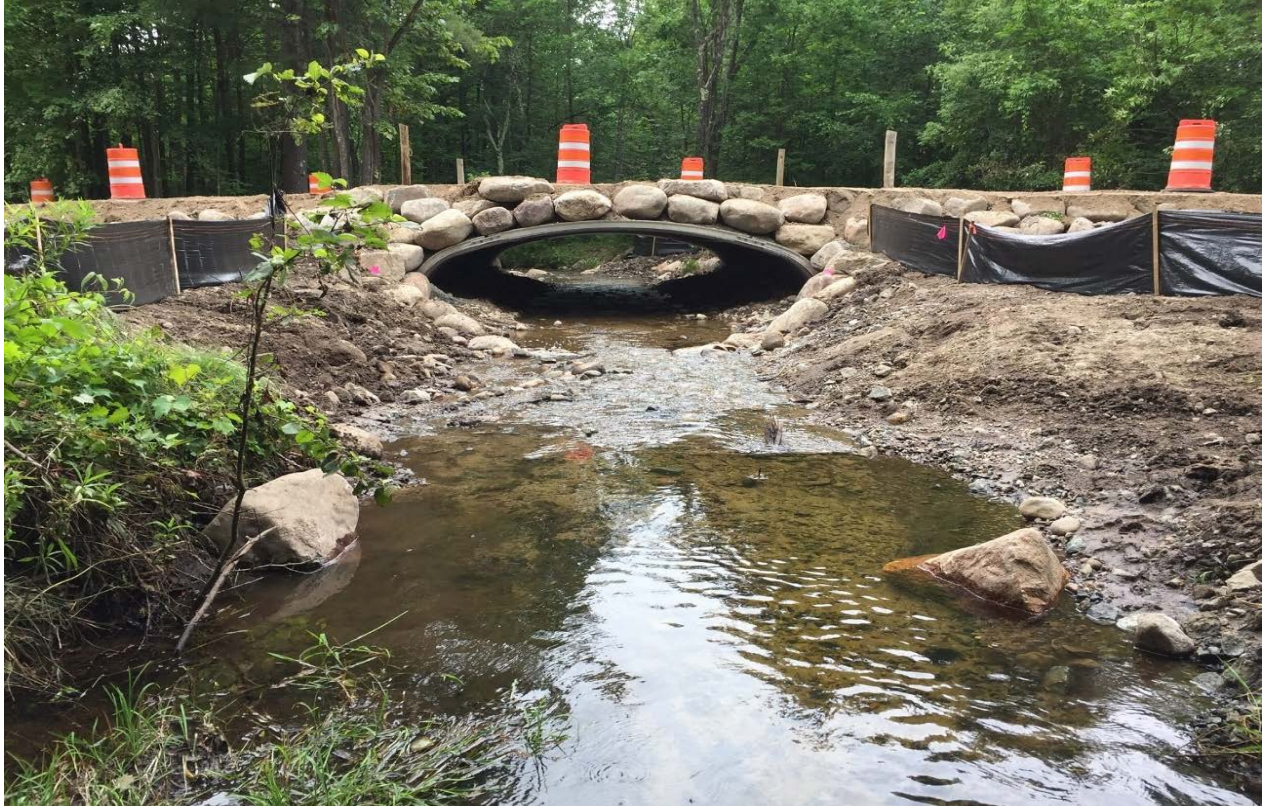
Fig. 4. An example of an attractive, effective, and flood-resilient road-stream crossing and redesign that reconnects the stream to its floodplain. The project is part of the Climate-Ready Culvert Initiative in the Ausable River watershed. Photo courtesy the Adirondack Almanack.

The only way to reconnect these streams to their floodplain is to remove the sections of Paul Spring Road that truncate the stream channels and to replace them with load-bearing, low-water crossings that freely allow stream flow in channels rather than through pipes (Fig. 4).
