The Policy & Practice of Stream Restoration

John Clayton Chapter of the Virginia Native Plant Society

September 15, 2022 Rod Simmons

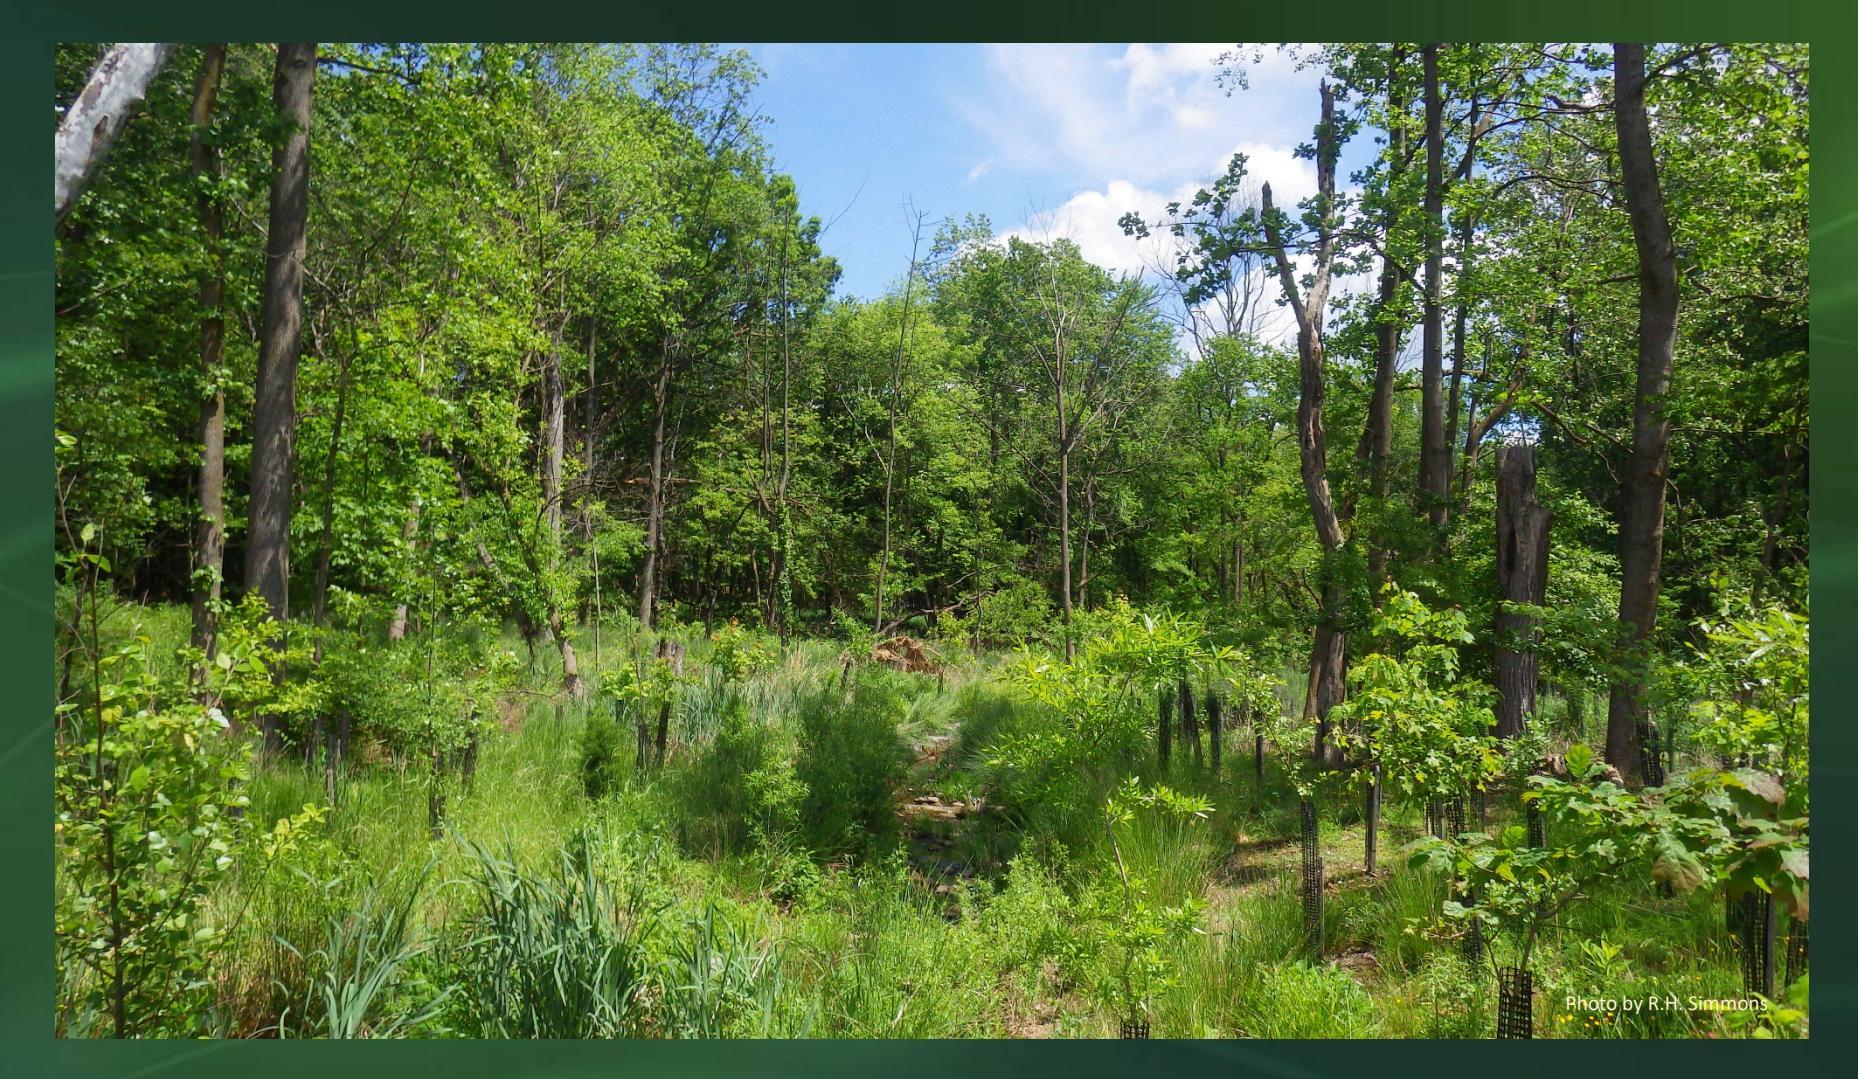
The denuded, post-construction footprint of a natural channel design (NCD) stream construction project along the north braid of the west branch of Turkeycock Run at Mason District Park in Fairfax County, Virginia. NCD and similar construction projects are highly destructive to forest communities and wetlands because they require extensive clearing of canopy trees and forest along the stream banks as staging areas and to create artificial floodplains and stream channels.

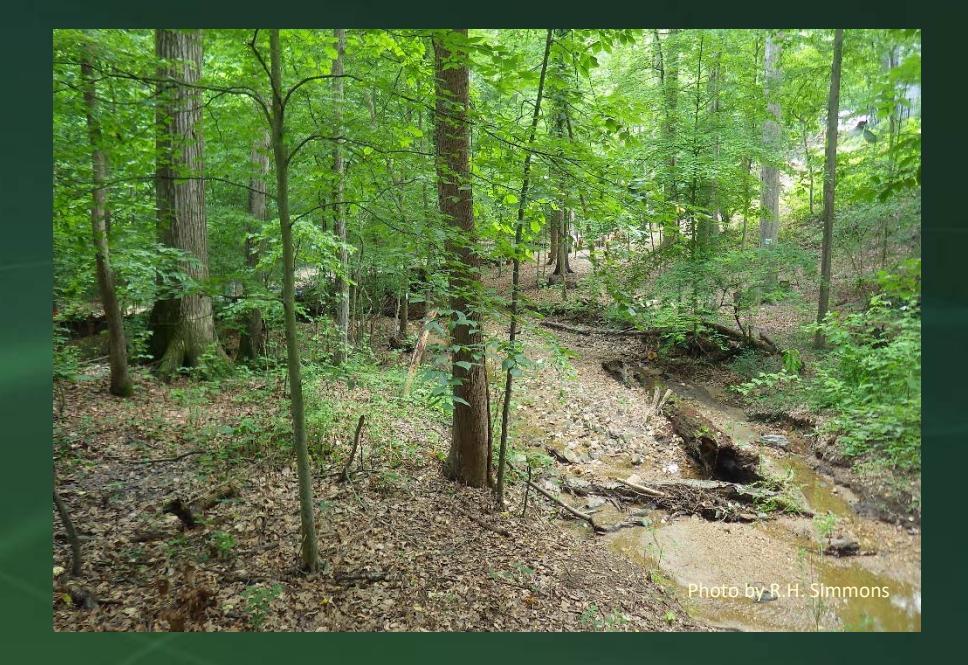
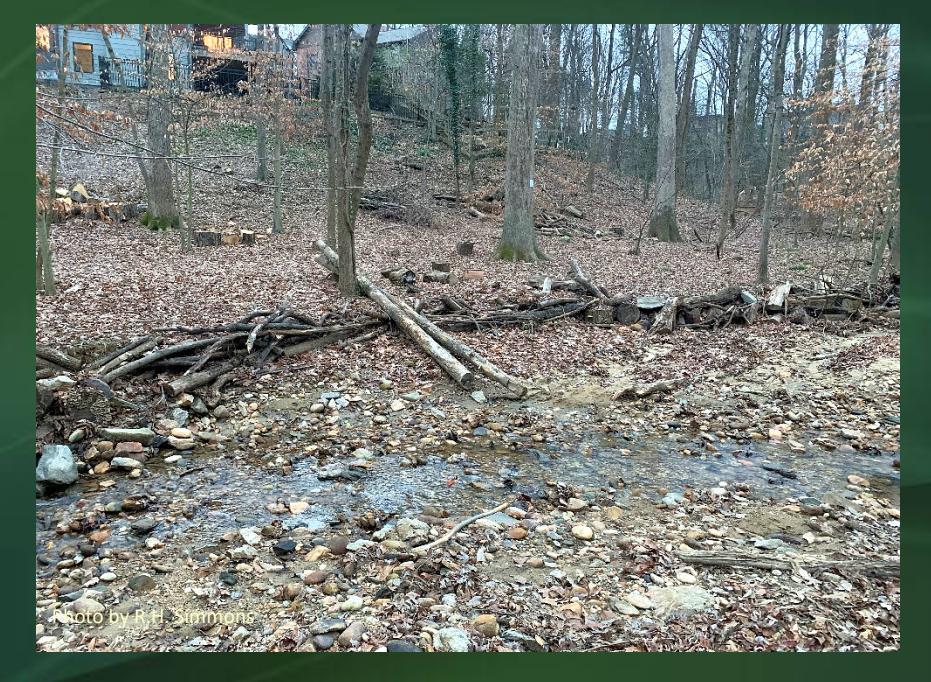
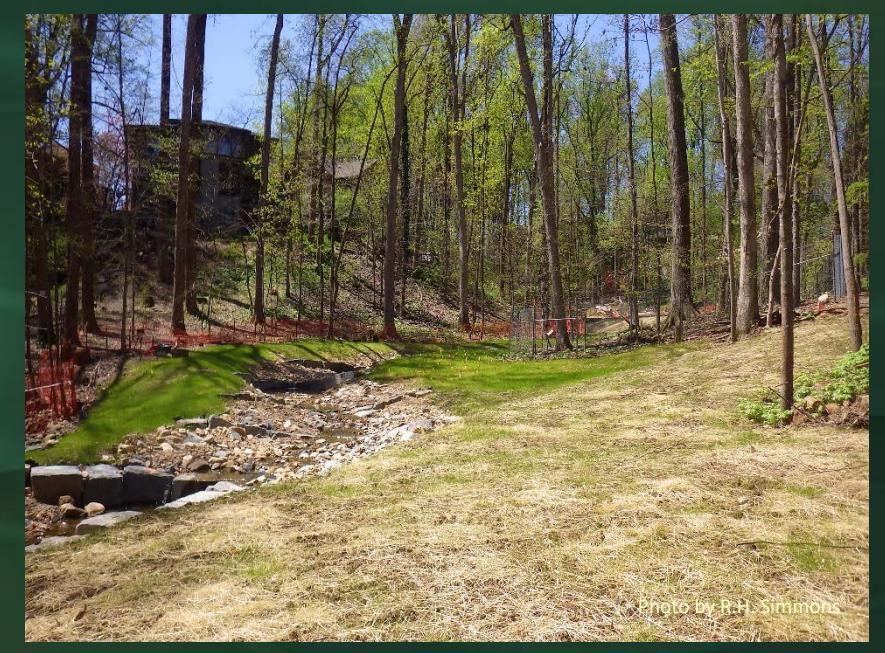
Egregiously misapplied recent NCD project along a privately owned section of Donaldson Run at Zachary Taylor Park in Arlington County, Virginia that unnecessarily clearcut a swath of old-age forest (top left). Bottom left: The same naturally shallow, cobbly section of stream that was enhanced naturally through the installation by hand of logs and wood along the very shallow bank by the property owner. Bottom right: April 2022 photo of recently completed NCD project in the same section of the stream. Much of the forested canopy and understory were razed to the ground, soil and topography regraded, and non-native turfgrass planted to create the artificial landscape.

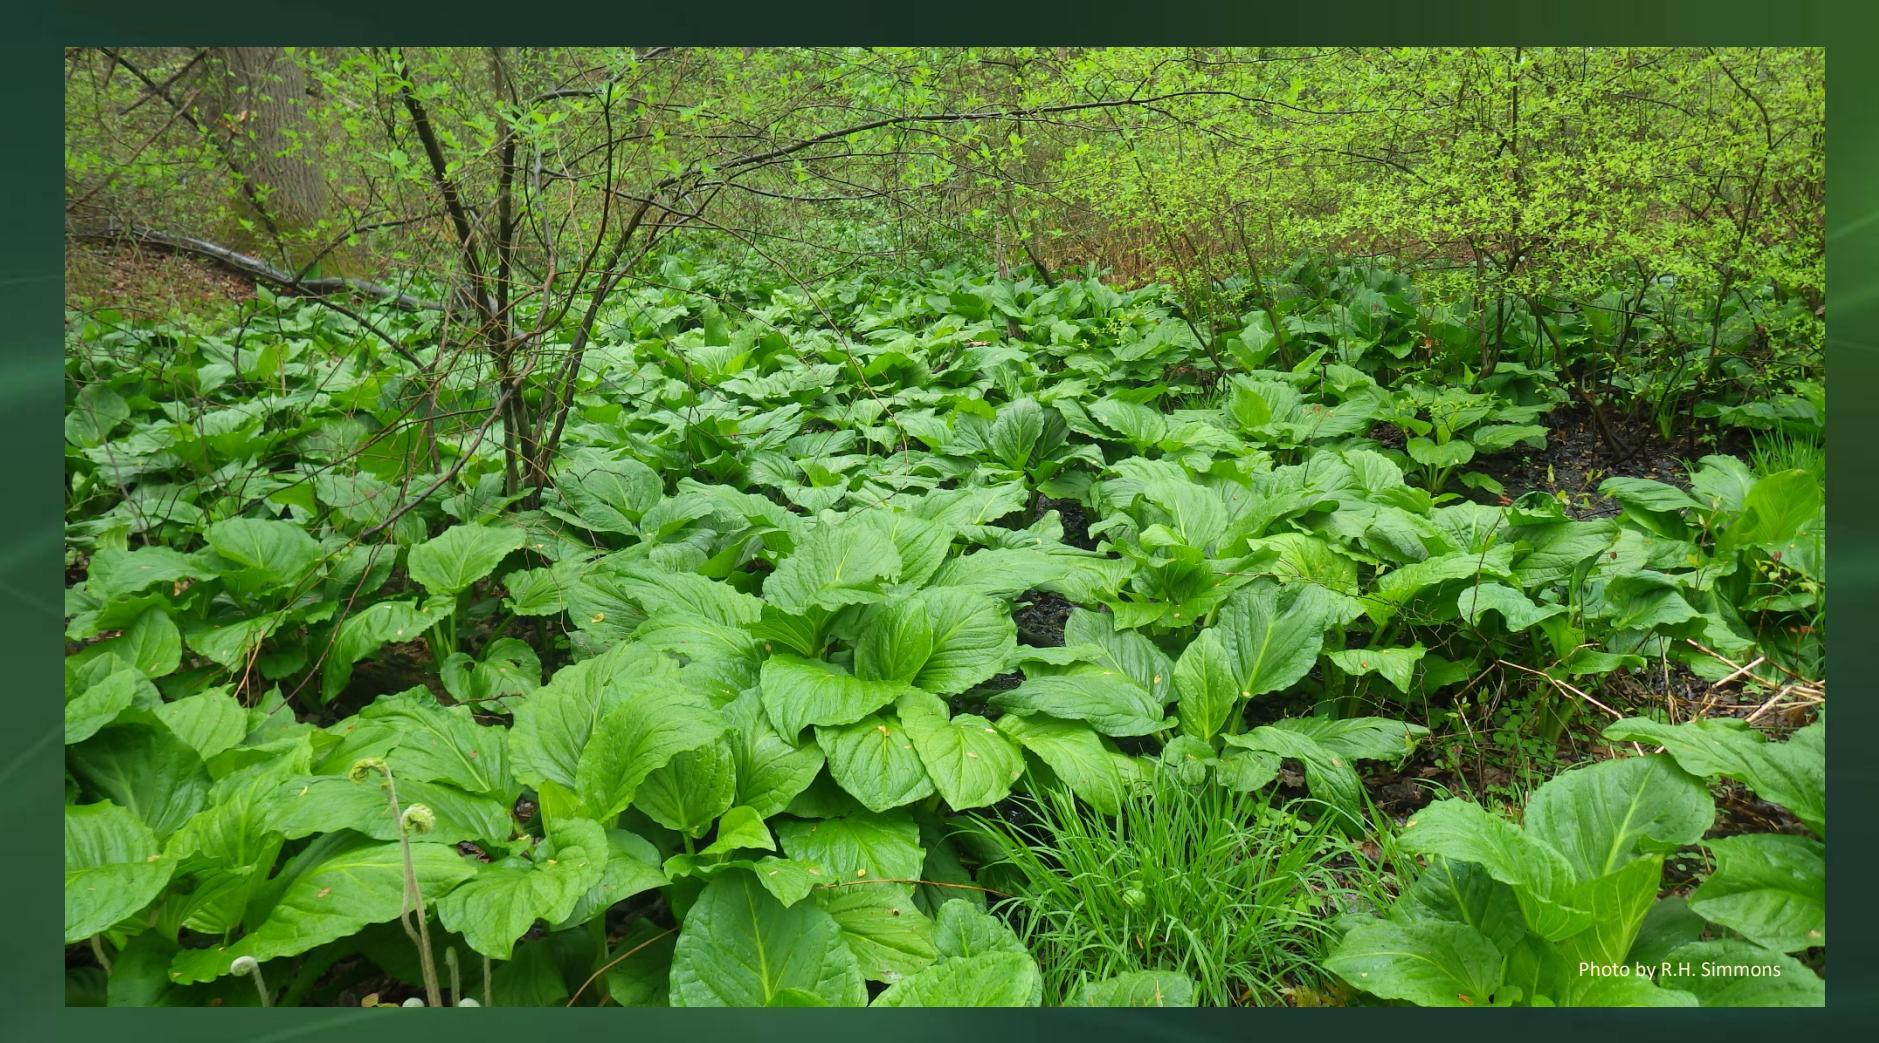
Globally and state rare Coastal Plain / Outer Piedmont Acidic Seepage Swamp (USNVC: CEGL006238) along the south bank of Taylor Run at Chinquapin Park in the City of Alexandria, Virginia. Despite some protection from encroachment, natural channel design will destroy this groundwater-controlled, *non-alluvial* wetland by creating an artificial floodplain where none naturally exists and using the non-alluvial wetland as an *alluvial* habitat to be washed out by overland flooding regimes. This violates the explicit terms and conditions of the Nationwide Permit 27 (NWP) because the "NWP does not authorize the conversion of a stream or natural wetlands to another aquatic habitat type."

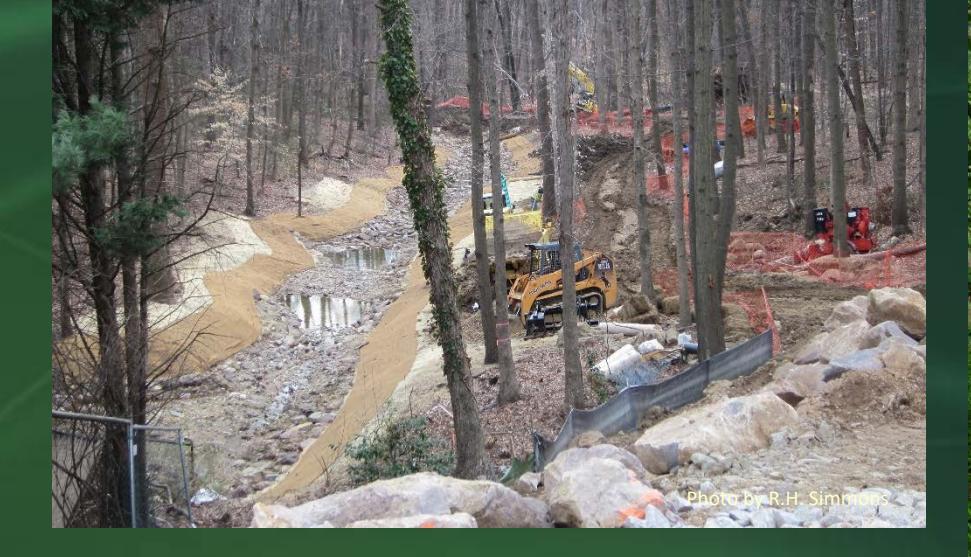
March 2012 NCD project along Winkler Run at the Winkler But of Alexandria, Virginia.

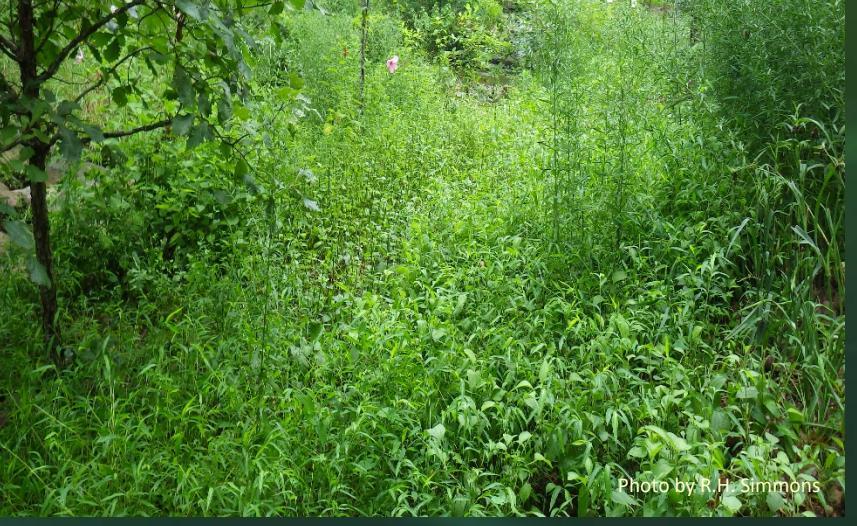
The same site in July 2017 completely engulfed in Japanese Stiltgrass (*Microstegium vimineum*) and other non-native invasive weeds.

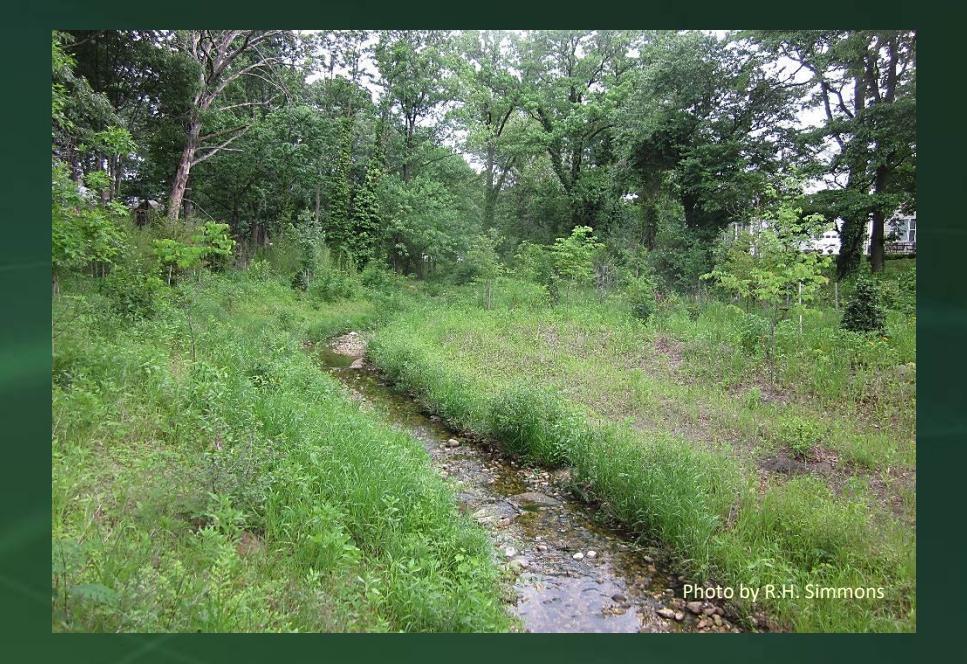
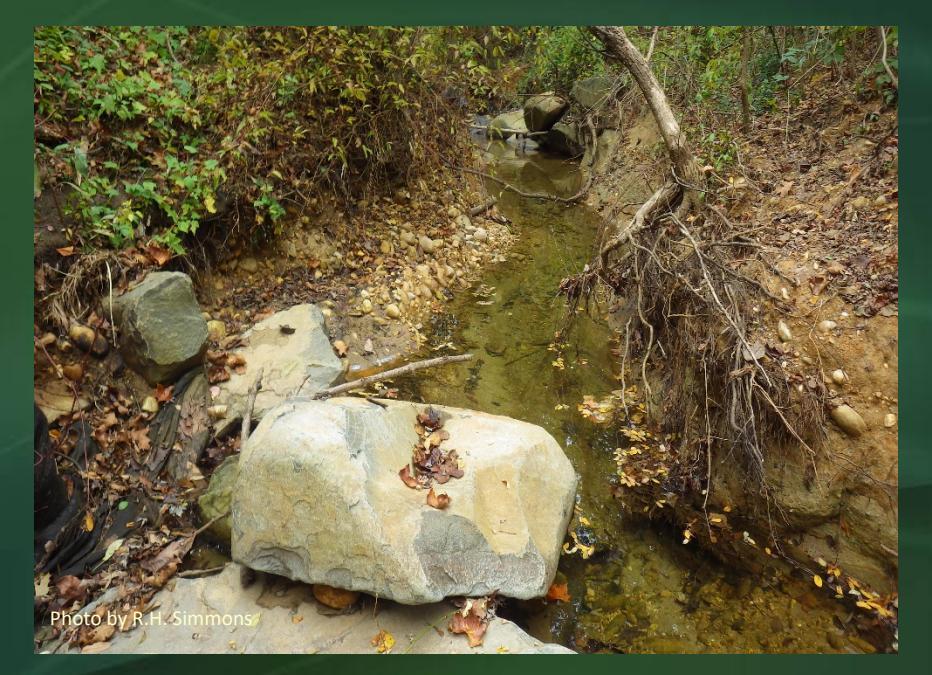
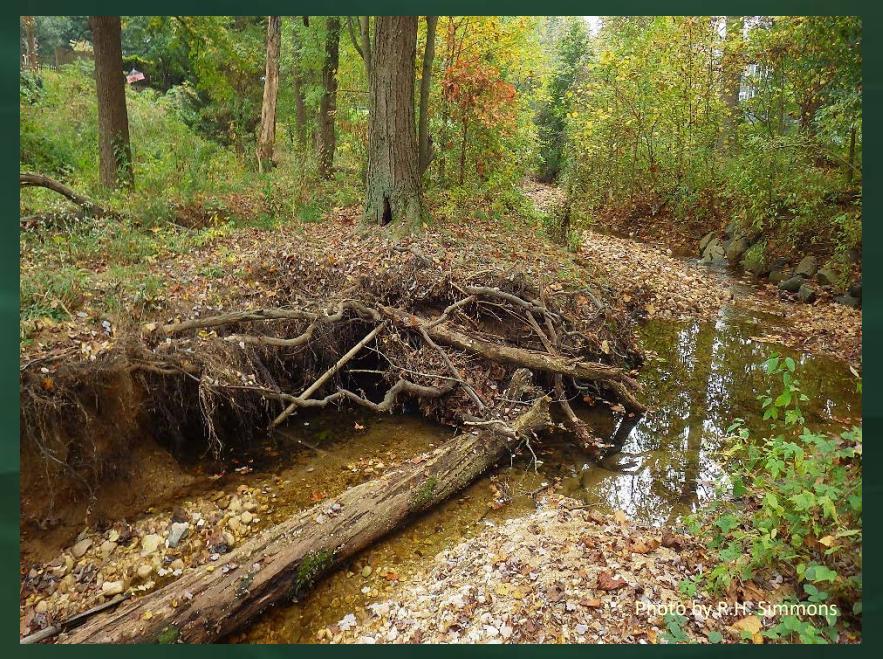
Failed 2010 NCD project along the lower section of Strawberry Run at Fort Williams Park, City of Alexandria, Virginia. Top left: View downstream from the bridge on May 24, 2011, a few months after the project completion. Bottom left: Blown out J-hooks and cross vanes and stormwater-mined soil (imported fill) scoured from the hardened sandstone and interbedded cobbles of the stream banks. Bottom right: The stream naturally restoring itself with wood snags and log jams, which trap sediment and provide aquatic wildlife habitat. The selective boulder armoring in sections of this small order, upper headwater stream was minimal and largely successful (right background of photo).

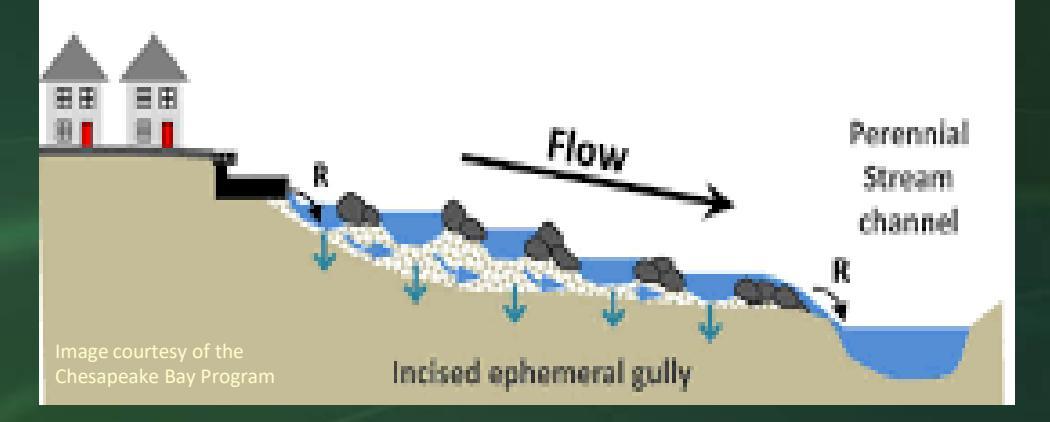
Step-pool stormwater conveyance: Longitudinal view

Regenerative Stormwater Conveyance (step pools) projects are every bit as destructive as NCD projects because both require extensive clearing and grading for construction access; both raise incised channels by filling them in with tons of imported soil, sand, woody material, and rock; and neither method can effectively mitigate unchecked stormwater runoff.
