# A LACK OF OVERSIGHT IMPERILS SEEPAGE WETLANDS AND FORESTED STREAM VALLEYS IN MARYLAND, D.C., AND VIRGINIA

By RODERICK H. SIMMONS

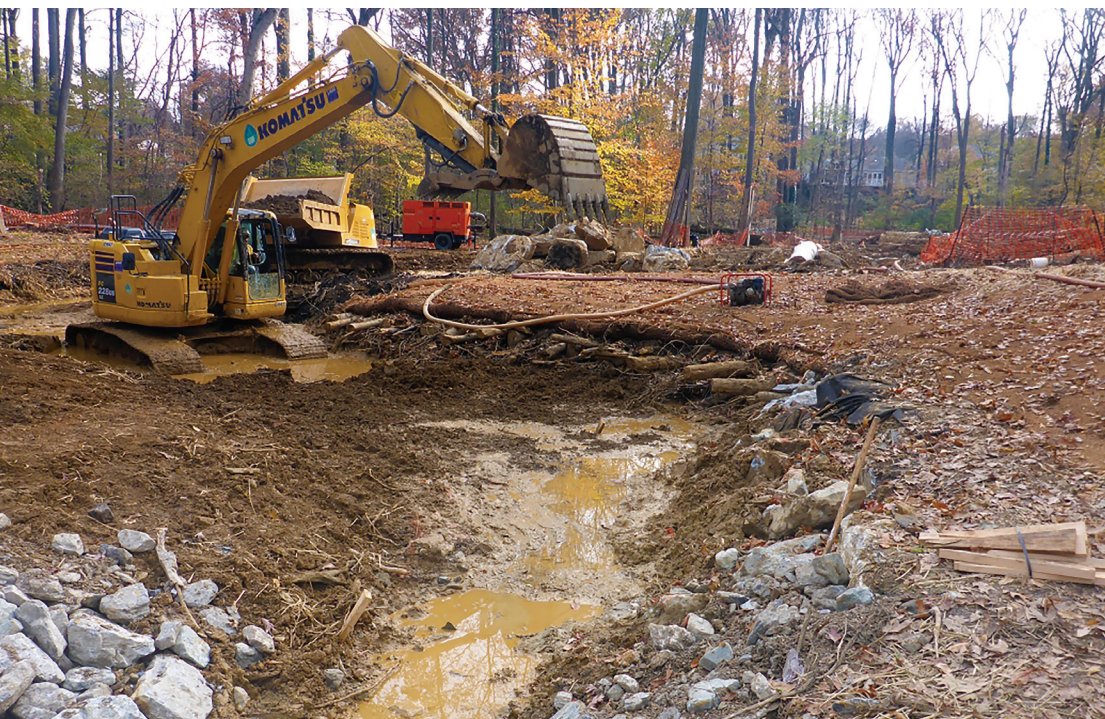
**Fig. 1.** A recent stream construction project at Upper Watts Branch Forest Preserve, City of Rockville, Maryland. Notice that the existing stream was completely destroyed to create an artificial floodplain by clearing the forested valley and raising the channel with tons of fill (sediment), tree trunks, and boulders. Photo by City of Rockville.

NATURAL CHANNEL DESIGN (NCD) is an engineering practice for stream reconstruction that attempts to mitigate the effects of uncontrolled stormwater runoff from upstream development. These projects are highly destructive to forest communities and wetlands because they require extensive clearing of canopy trees and forest along the stream valley to create artificial floodplains where none naturally exist (Fig. 1). The process involves

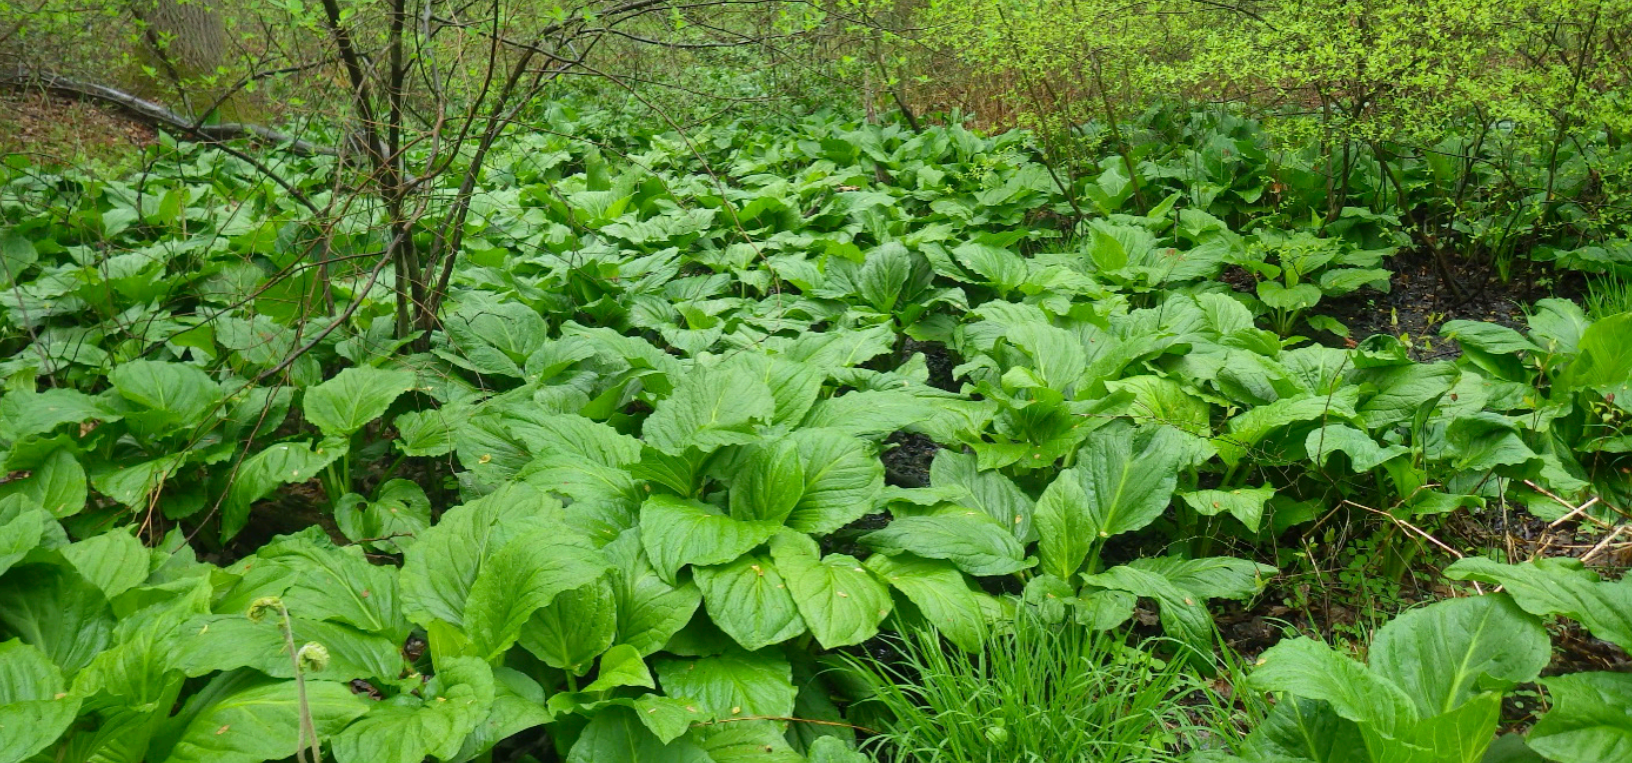
**Fig. 2.** Coastal Plain / Outer Piedmont Acidic Seepage Swamp: *Acer rubrum* - *Nyssa sylvatica* - *Magnolia virginiana* / *Viburnum nudum* / *Osmundastrum cinnamomeum*—*Woodwardia areolata* Forest (USNVC: CEGLO06238) along the south bank of Taylor Run at Chinquapin Park in the City of Alexandria, Virginia. Despite some protection from physical encroachment, natural channel design construction will destroy this groundwater-controlled, non-alluvial wetland by creating an artificial floodplain where none naturally exists and using the non-alluvial wetland as an alluvial habitat to be washed out by overland flooding regimes. *Photo by R.H. Simmons.*

Degrading and potentially destroying non-alluvial seepage wetlands for the purpose of stormwater management impermissibly converts these highly functioning wetlands into another aquatic type (Figs. 2 & 3).

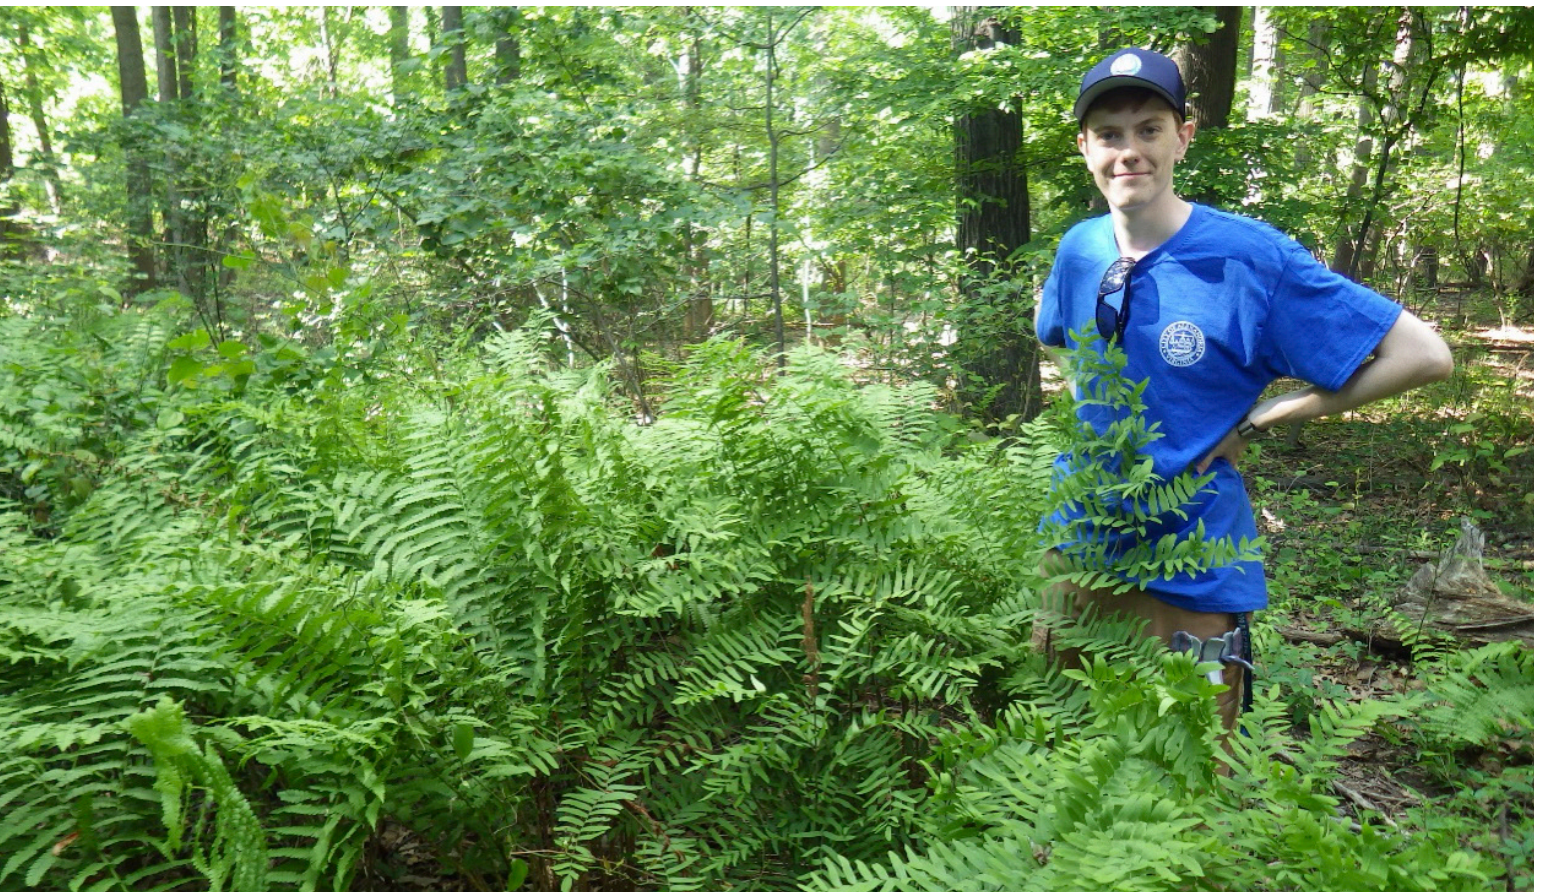
**Fig. 3.** Huge ferns and a series of acidic woodland seeps along the south branch of Lucky Run in the City of Alexandria, Virginia are critically imperiled by a misapplied natural channel design project that plans to flood the wetlands with unchecked stormwater runoff from I-95 and other impervious surfaces. Acidic woodland seeps are also non-alluvial wetlands and are intermediate in floristic diversity between Magnolia Bog and Acidic Seepage Swamp communities (Simmons 2015). *Photo by R.H. Simmons.*

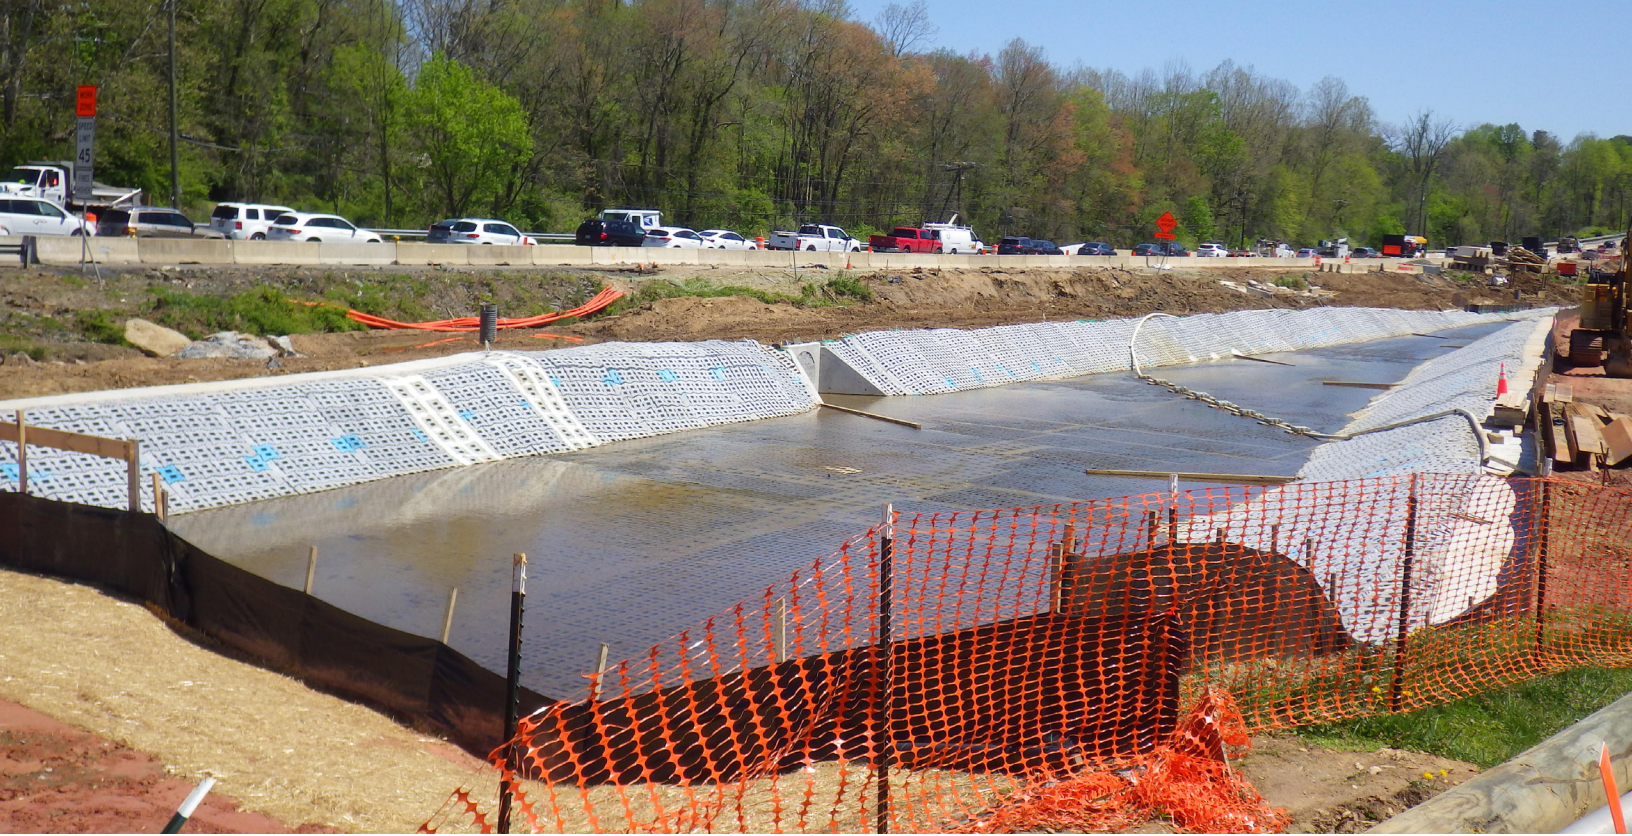
**Fig. 4.** A recently constructed massive drainage channel replacing a section of 1960s-relocated Colvin Run in Fairfax County, Virginia. Leesburg Pike (Rt. 7), shown in photo center, is being doubly widened. A large Piedmont / Northern Coastal Plain Basic Seepage Swamp (USNVC: CEGLo06406) runs along the south side of the above channel outside of the right photo frame. Despite the denuded, degraded landscape, the concrete channel is the only way to confine and accommodate enormous quantities of stormwater runoff from the widened roadway and environs without transferring it to forested wetlands and stream valleys, especially with 72" culvert outfalls aimed at said wetlands (middle left of photo). *Photo by R.H. Simmons.*

swamp at Difficult Run by not allowing NCD. This required the large, straight concrete channel to protect the non-alluvial forested wetlands (Fig. 4). “Of 10 total options considered for Colvin Run with input from the environmental agencies, this option was determined to be the least environmentally impactful” (Hobson 2021). Perhaps if stormwater management agencies and consultants would direct their agendas to upholding environmental regula-
